# PLANT BREAKDOWN & RUST

# BREAKDOWN OF THE STEP-UP GEAR BOX (SUG)

# WASTAGE IN THE MARGINS

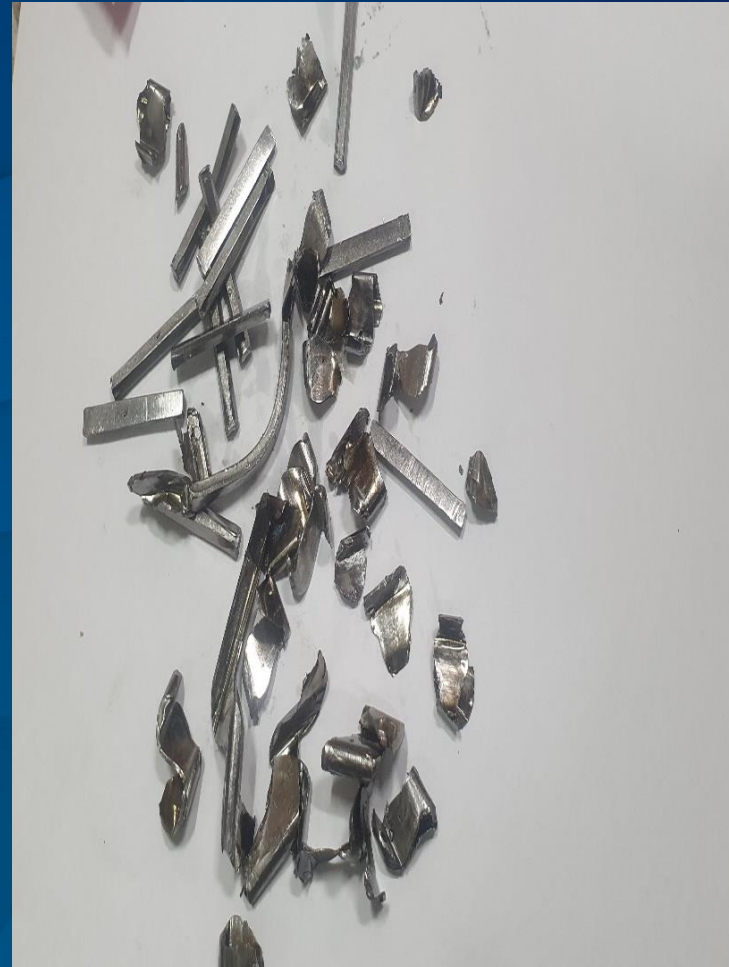
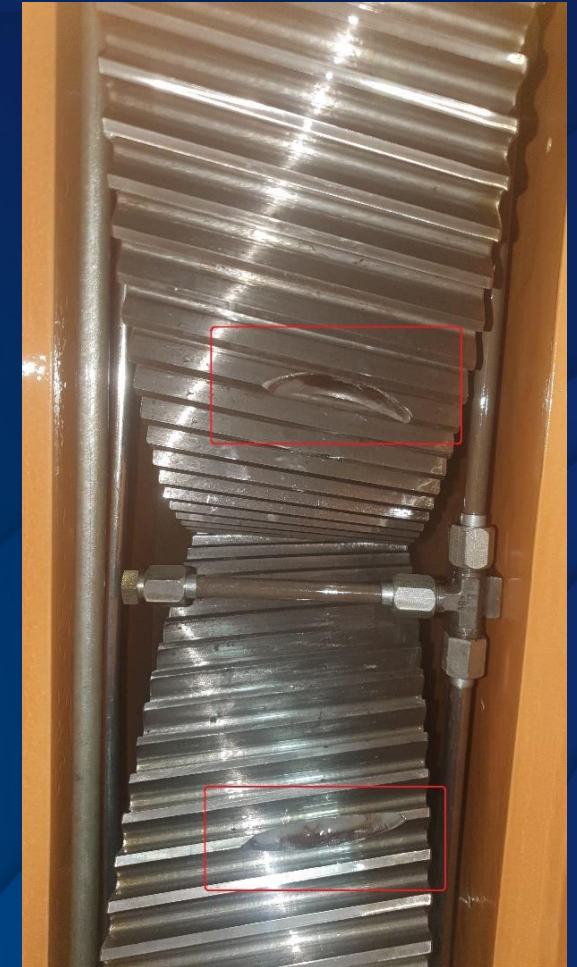
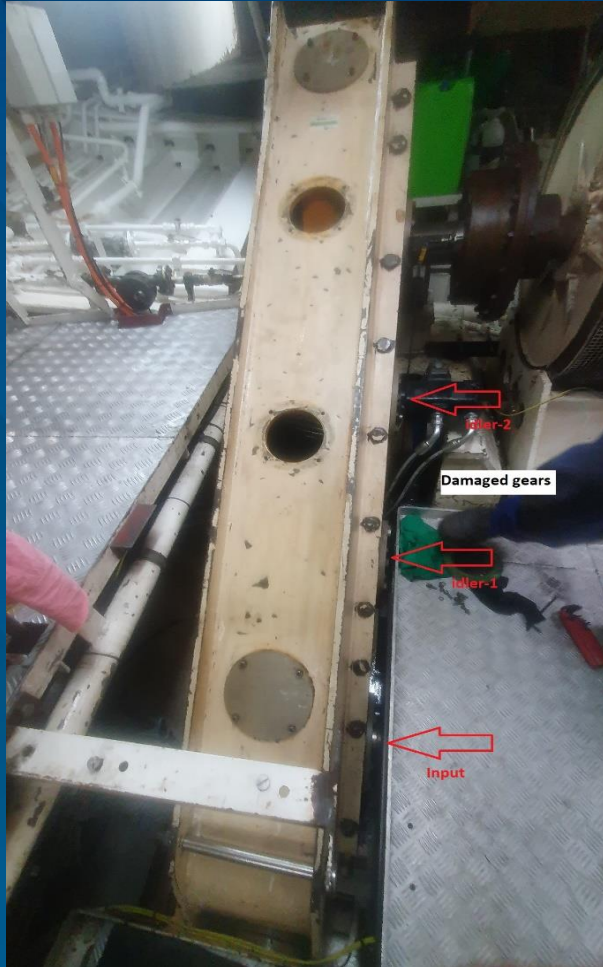
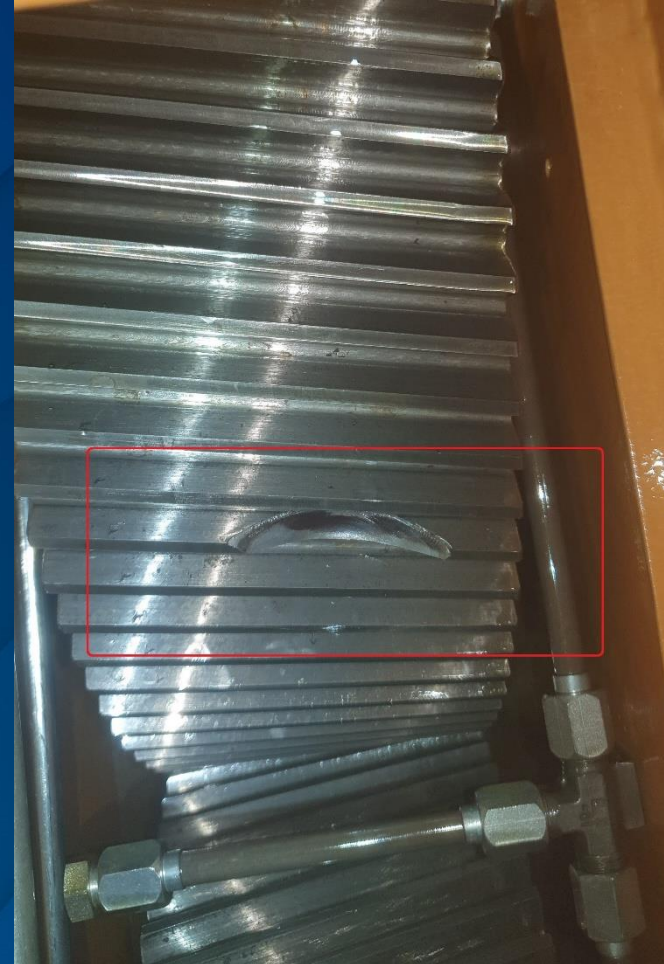
**Collapse of bearing cage  
damaged the gear teeth**

**Identified during a planned  
oil change**

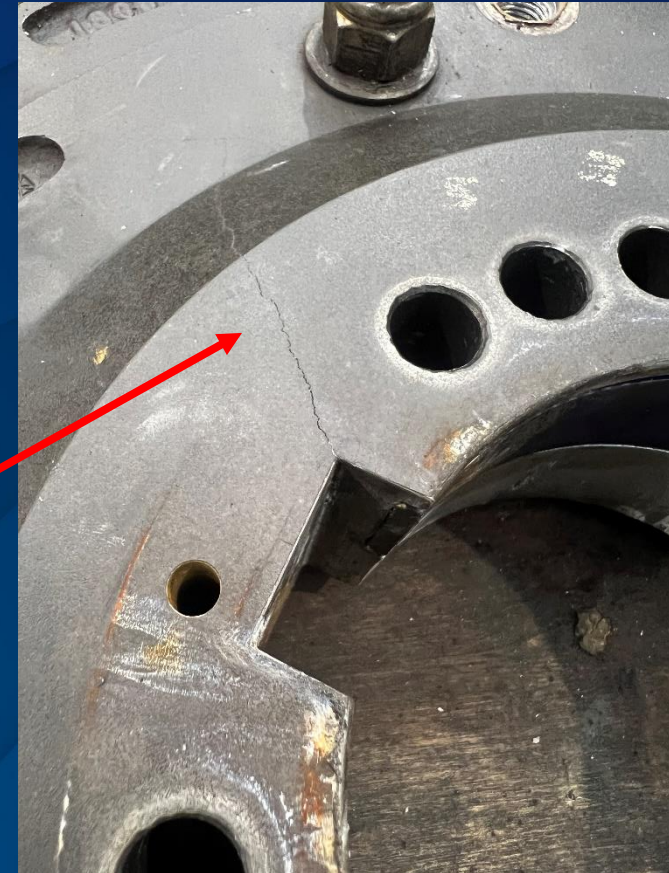
Crack in Logan clutch hub

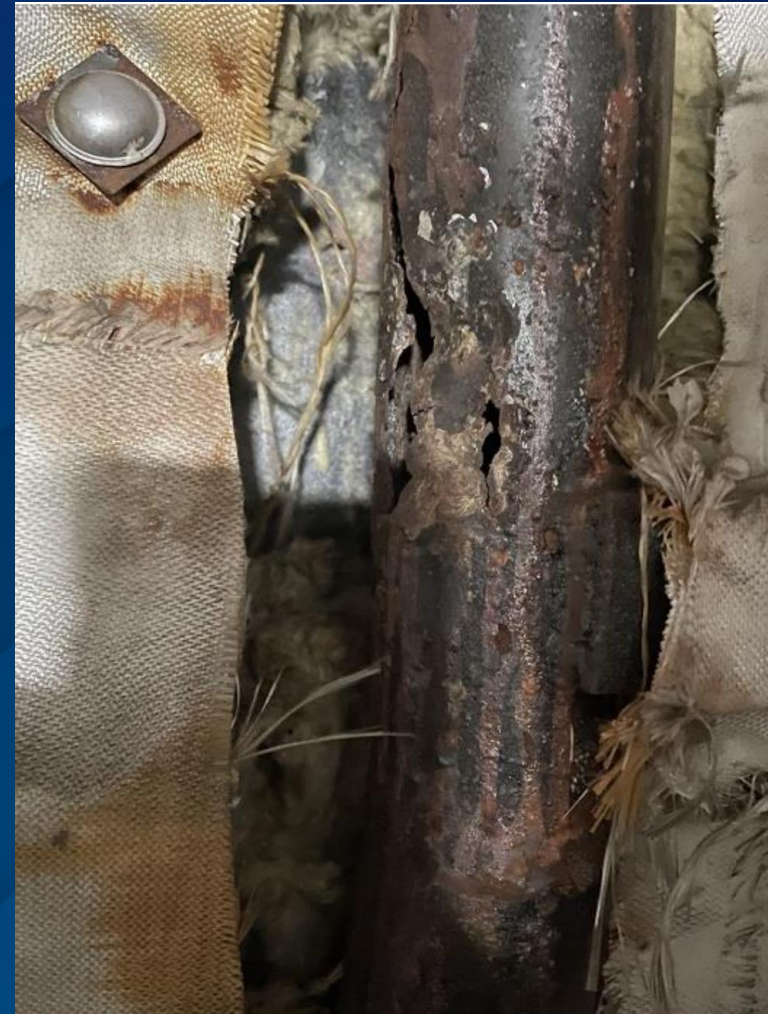
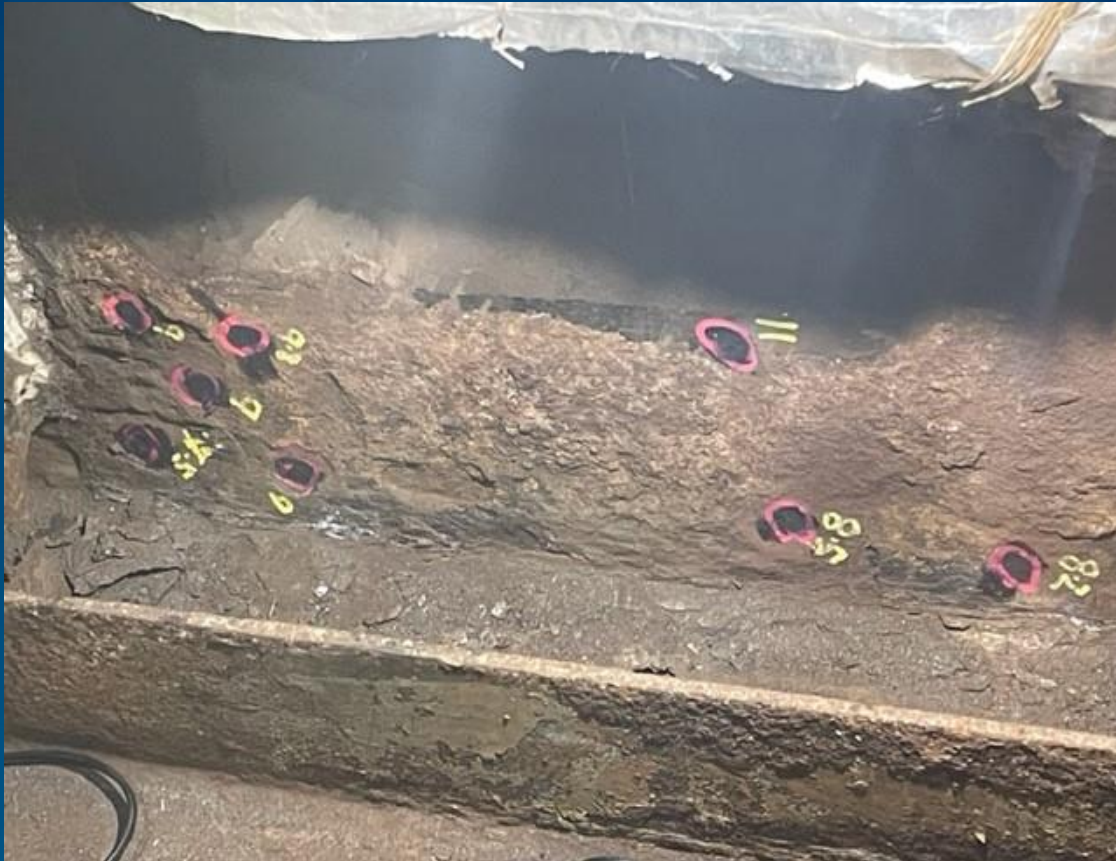
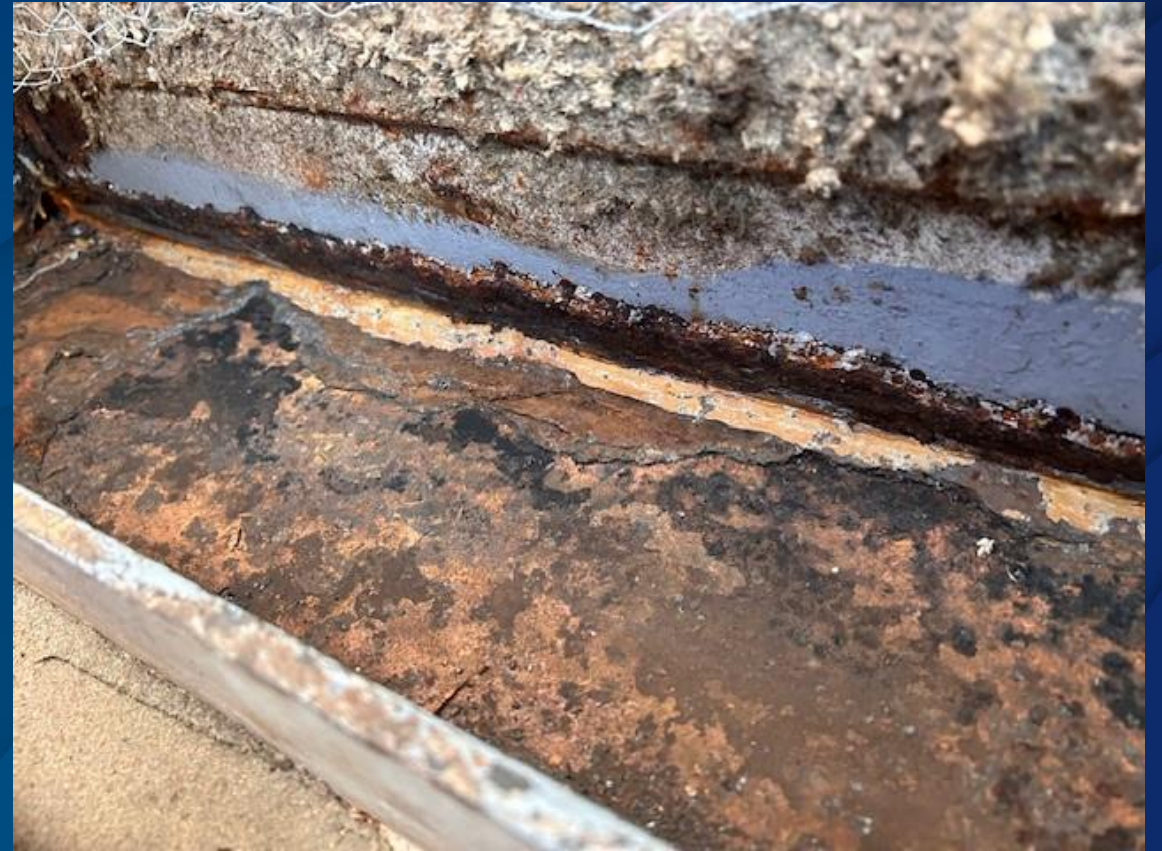
**Water drips into the generator room were traced back to the fan room space**

**Invasive investigation plan was executed  
removal of linings, insulation, plate  
thickness readings and pipe work**

**Underwater UT Readings of hull plating**

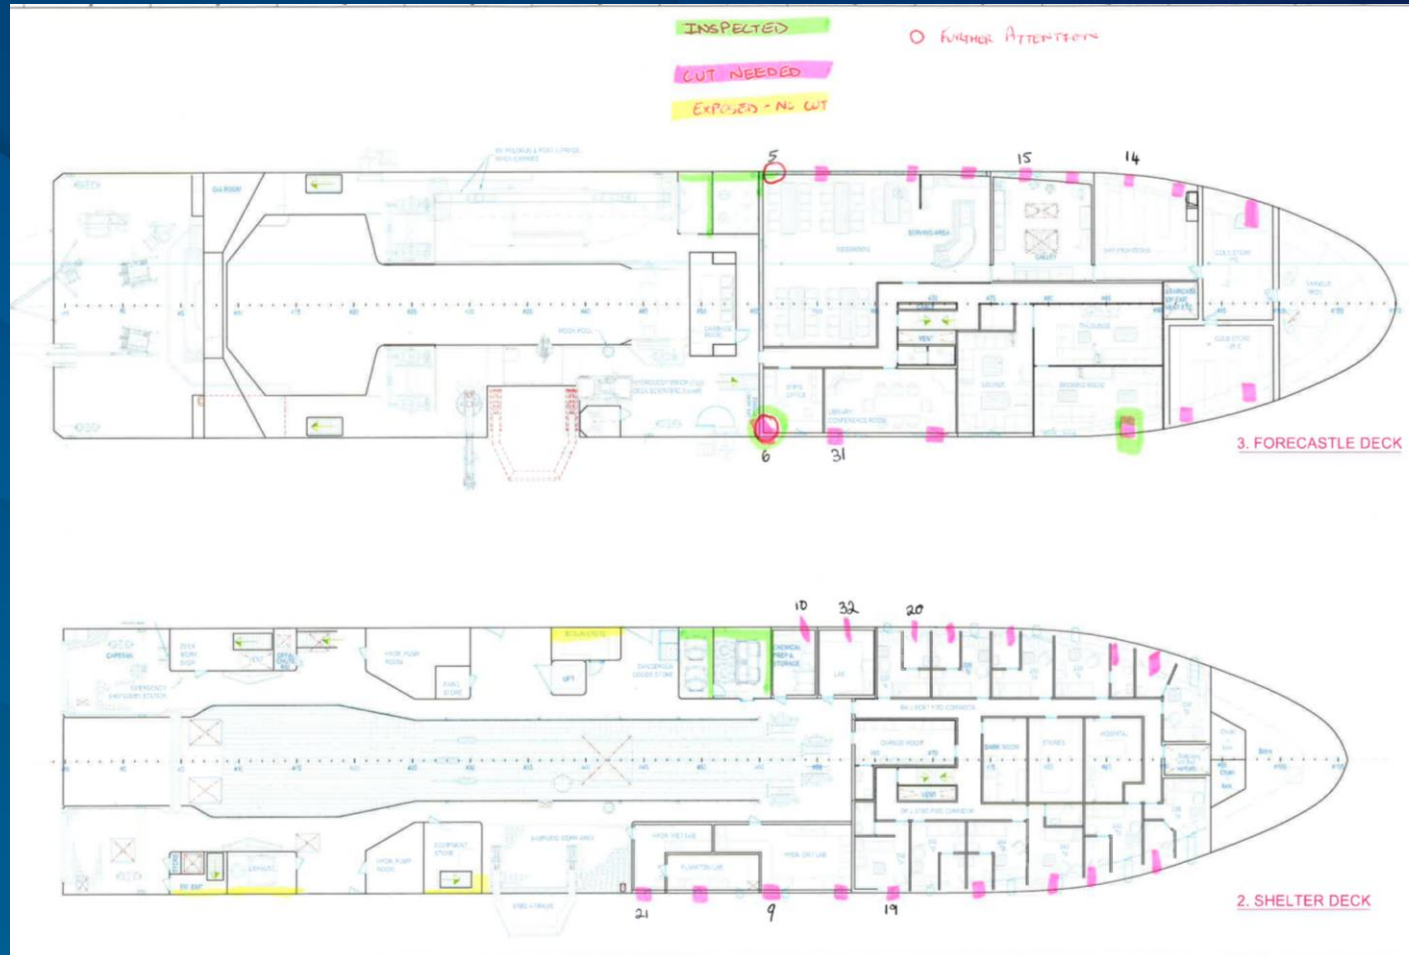
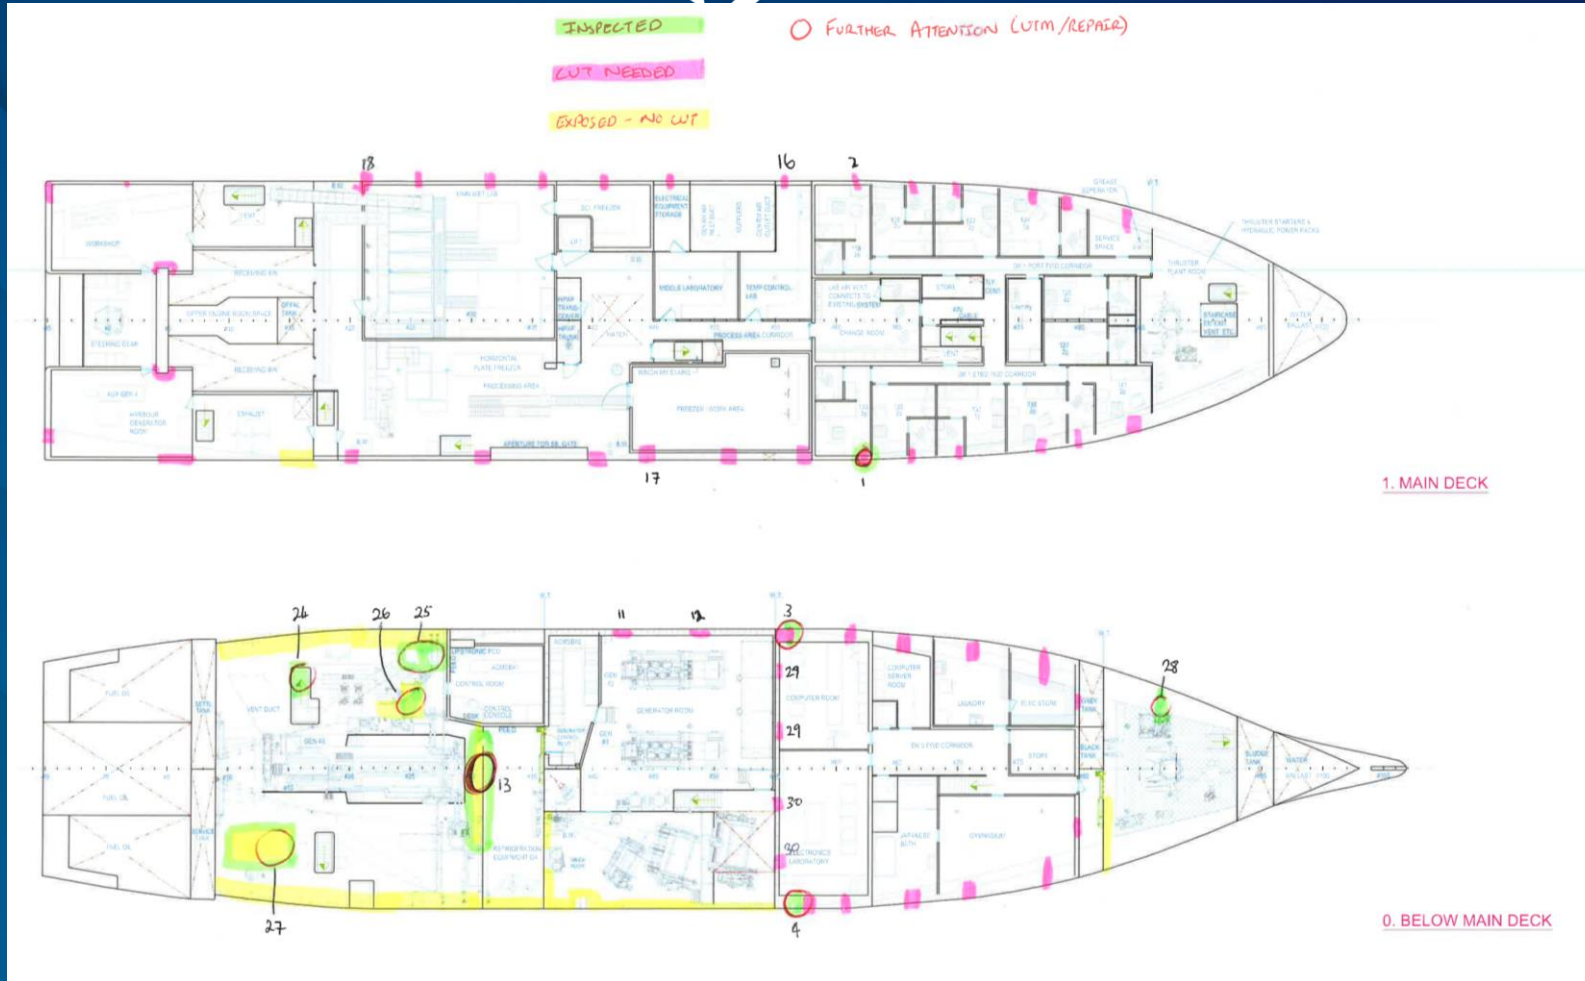
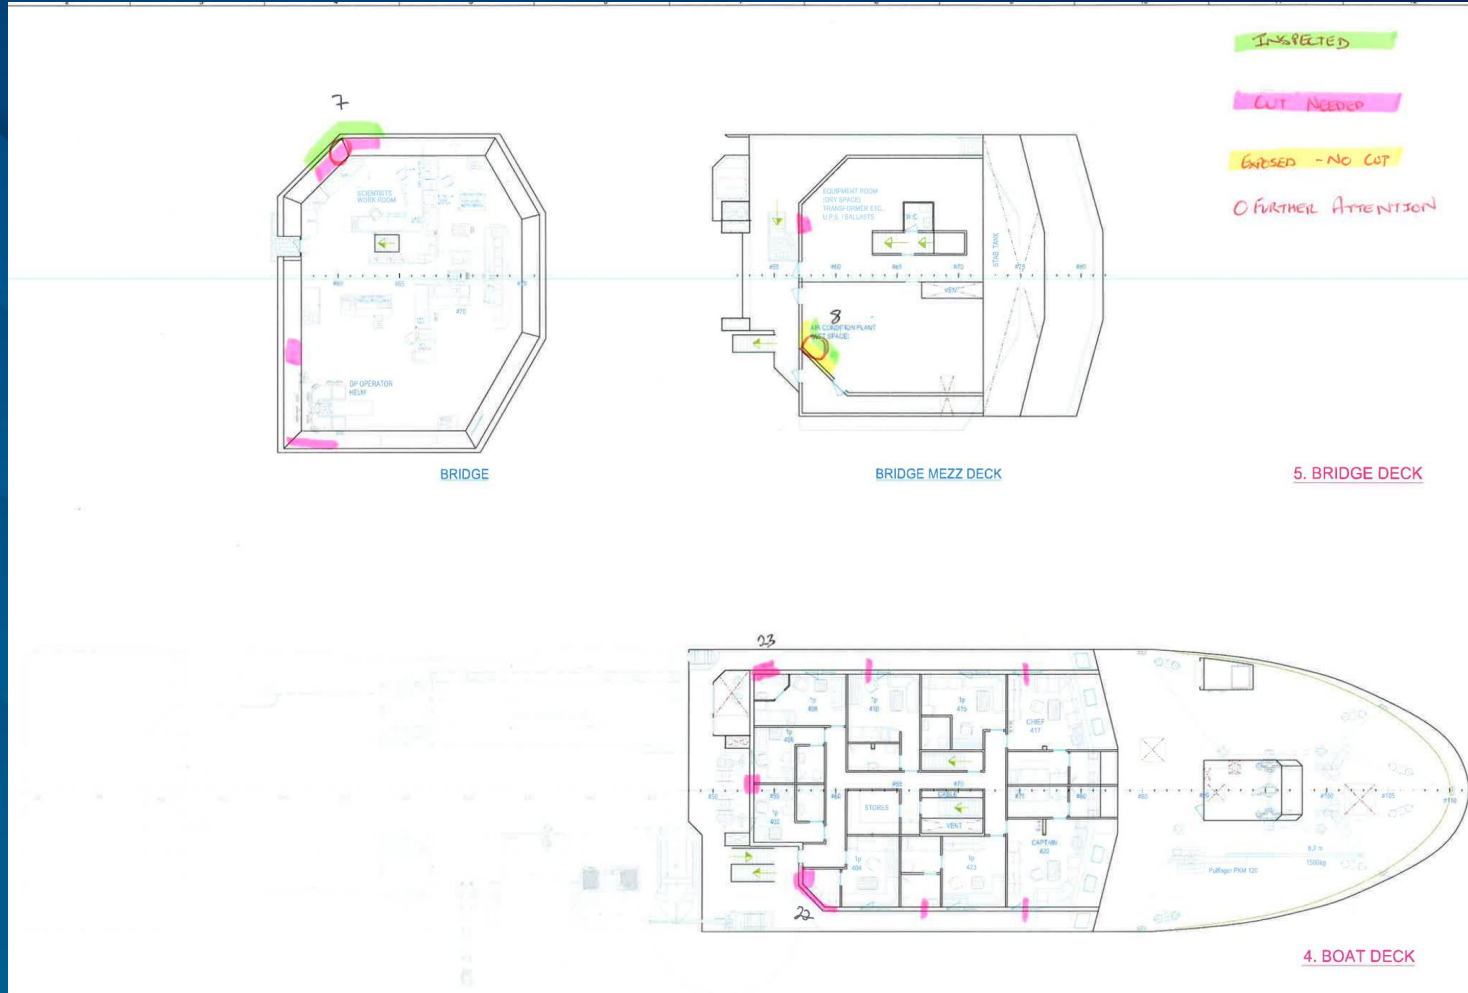
# INVESTIGATION PLAN

**Thickness measurements of affected areas and surrounding shell plating, allowed us to identify the pattern of deterioration and establish a scope of repairs.**

**The pattern highlighted wastage in the 1/3 aft sections and corners of the accommodation where the downpipes were located and aft lateral margins. Which is consistent with the vessel trim and expected flow of any moisture.**
