# PLANT BREAKDOWN & RUST

# BREAKDOWN OF THE STEP-UP GEAR BOX (SUG)

# WASTAGE IN THE MARGINS

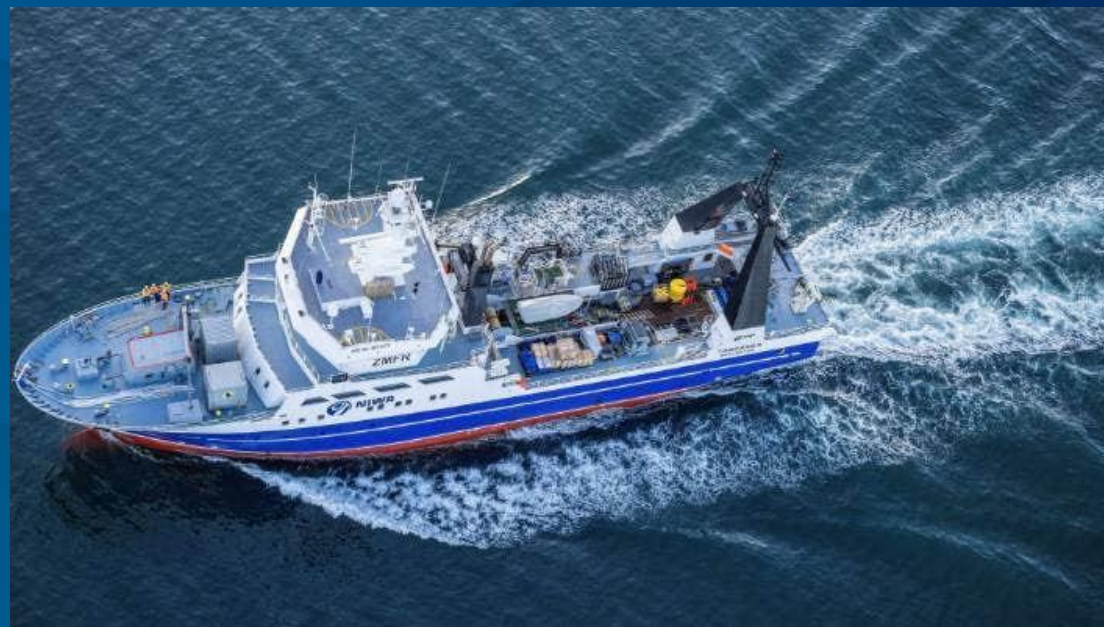
## SUG FUNCTION

The main engine drives the propeller shaft through a primary gear box. This gear box has a power take off shaft that is utilised to drive a “shaft” generator for ships electrical power generation.

The SUG is between the power take off from the primary gearbox and the generator and increases or “steps up” the speed to allow correct frequency electricity to be generated.

**Collapse of bearing cage  
damaged the gear teeth**

**Identified during a planned  
oil change**

# REPAIR PLAN

Removal and install scheduling

Machining time for a set of gears

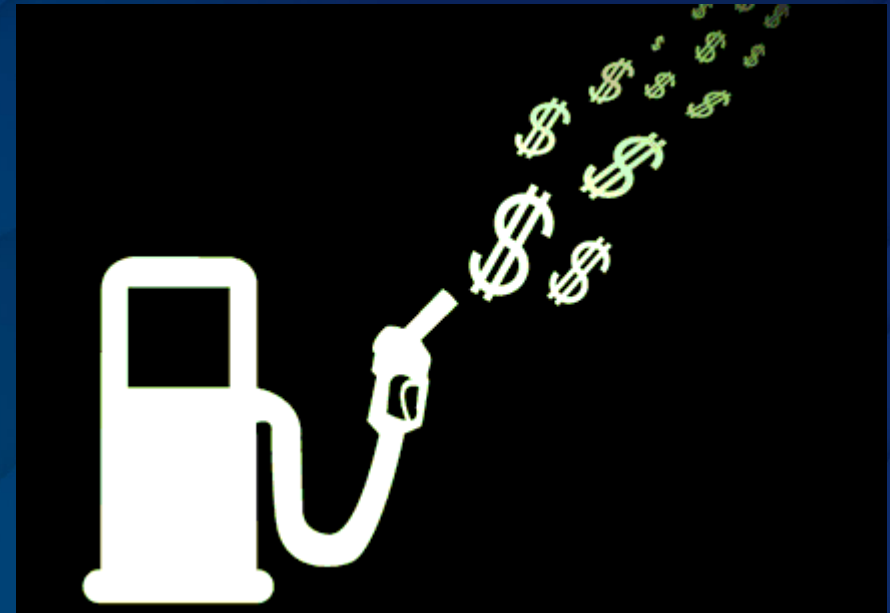
## IMPLICATION OF NO SUG

**Fuel consumption – additional 2000  
litres / per standard operational day**

**Increase of emissions**

**Reliance and additional load or back-up  
generators**

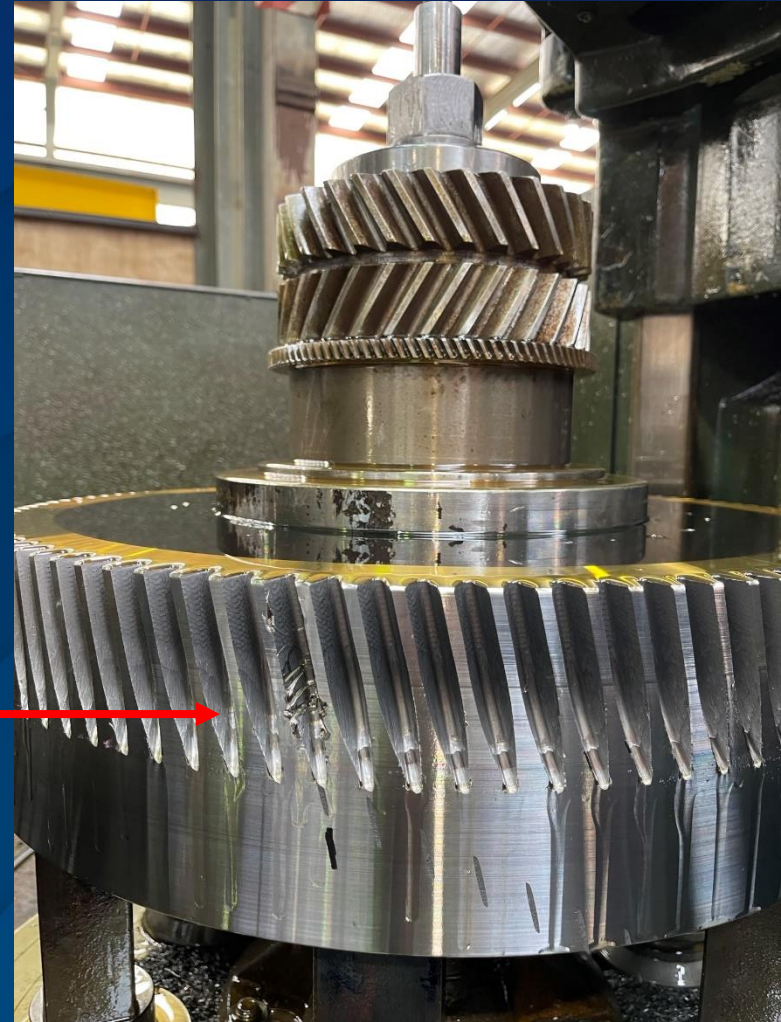
## CHALLENGES

**Delays with raw materials**

**Damage to idler shafts during disassembly**

**Re-work of gears due to incorrect machining process**

**Contractor holding all parts with no initial inspection of complete assembly**

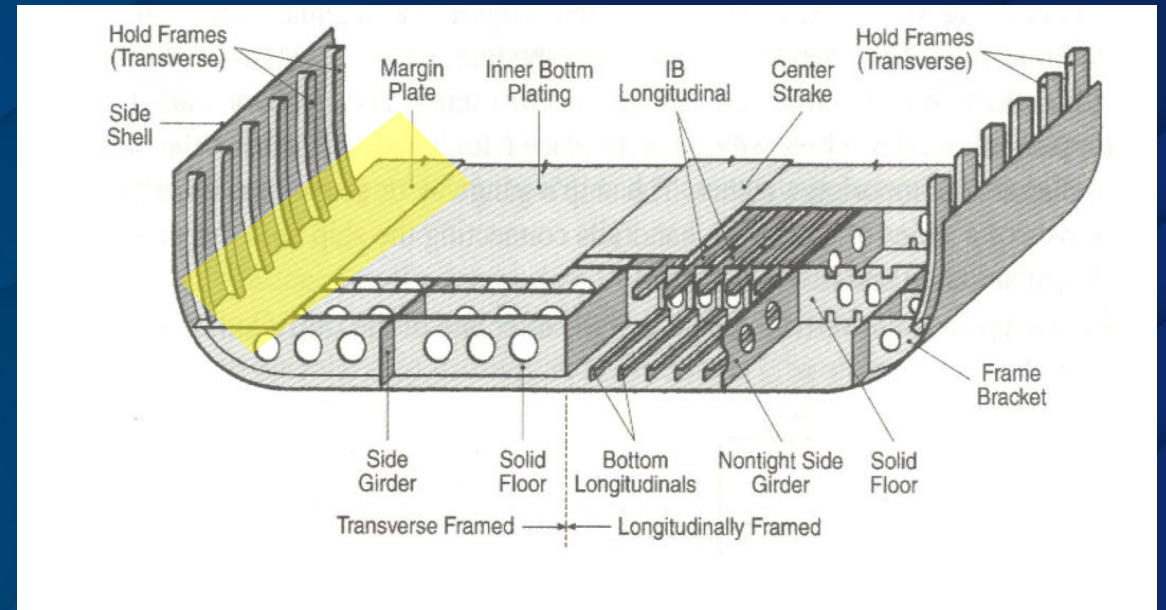
## **DISCOVERY**

**Water drips into the generator room were traced back to the fan room space**

**Invasive investigation plan was executed  
removal of linings, insulation, plate  
thickness readings and pipe work**

**Underwater UT Readings of hull plating**

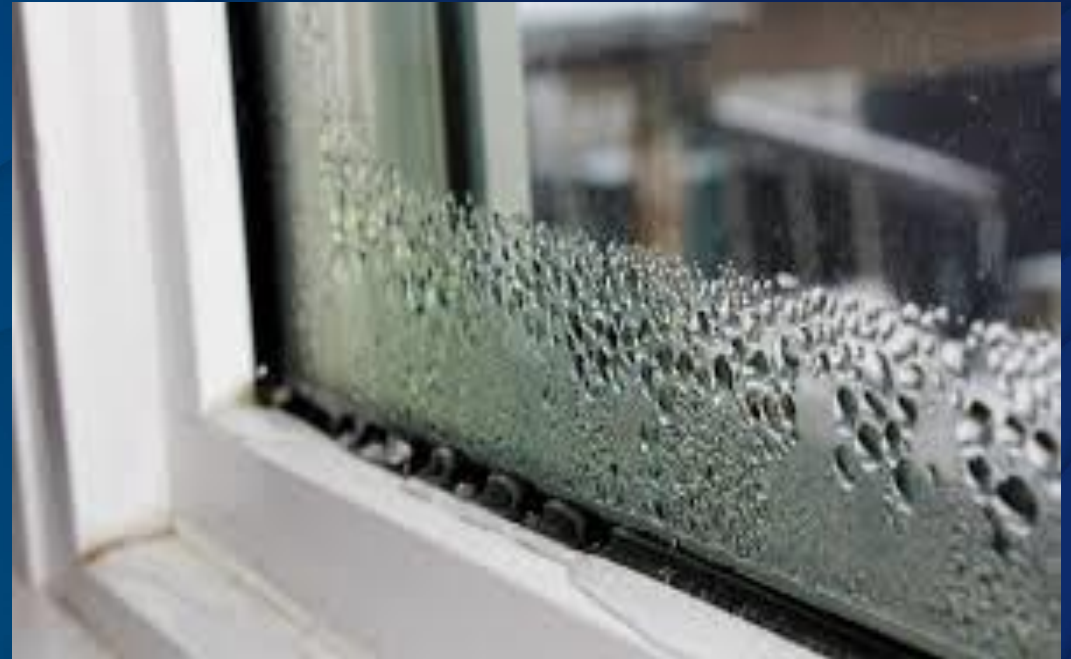
## CONTRIBUTING CAUSES

**Age of the vessel 32 years**

**Leakage from window drains**

**High salt condensate and sweating behind the insulation**

**Rotted pipe work**

**Lack of invasive inspection**
